Magnetic Filtration Testing

Manufacturer: One Eye Industries
Inc.

Date: 05 November 2007

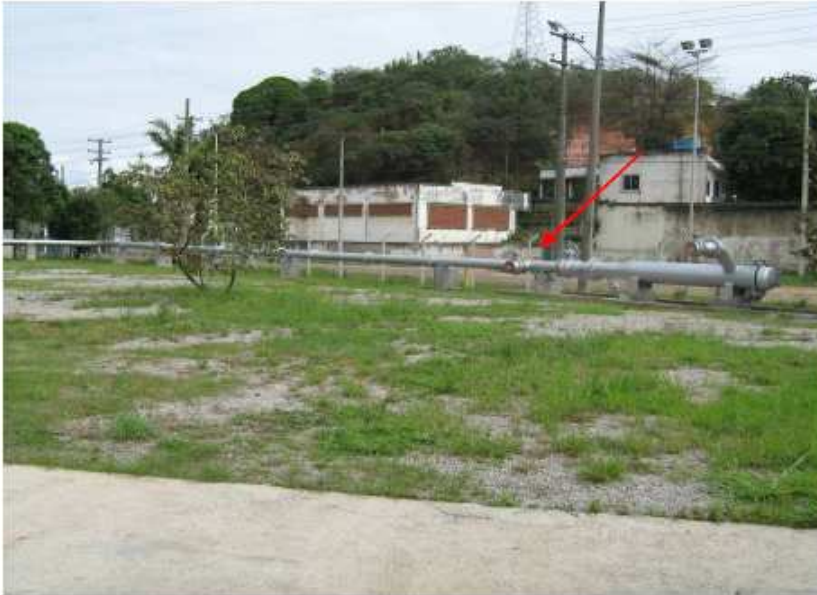
Photo A – 14” Loop red arrow indicating location of the Magnetic Filter

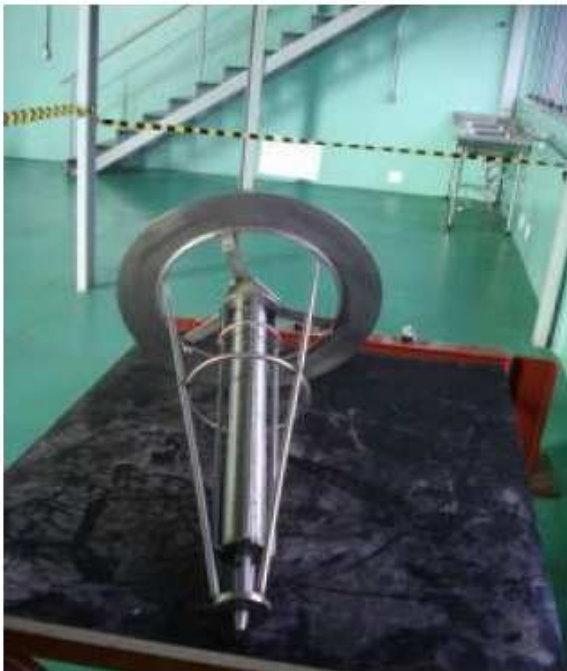
Photo B – Magnetic Filter

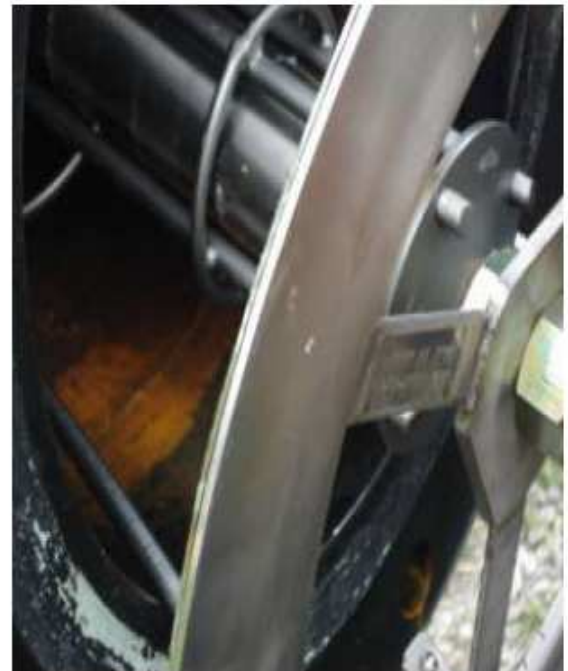
Photo C – Location of the Magnetic Filter (30 Oct 2007)

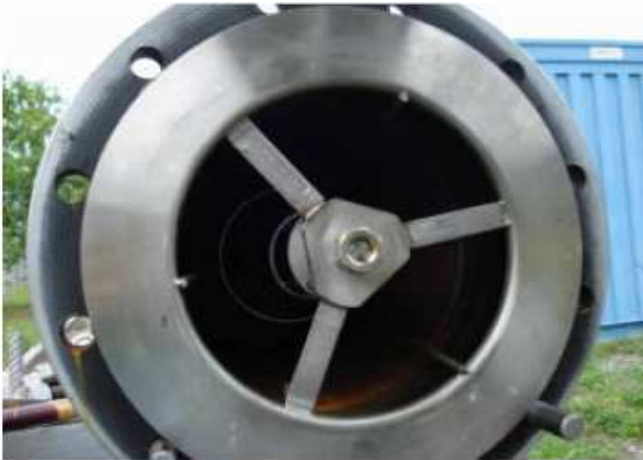
Photo D - Magnetic Filter (30 Oct 2007)

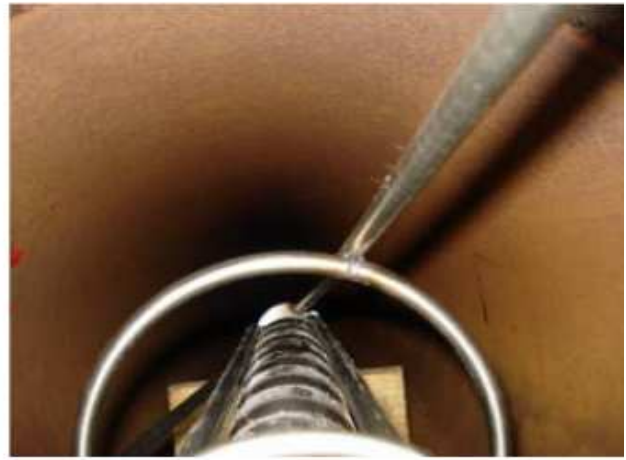
Photo E - Magnetic Filter inside 14" loop (30 Oct 2007)

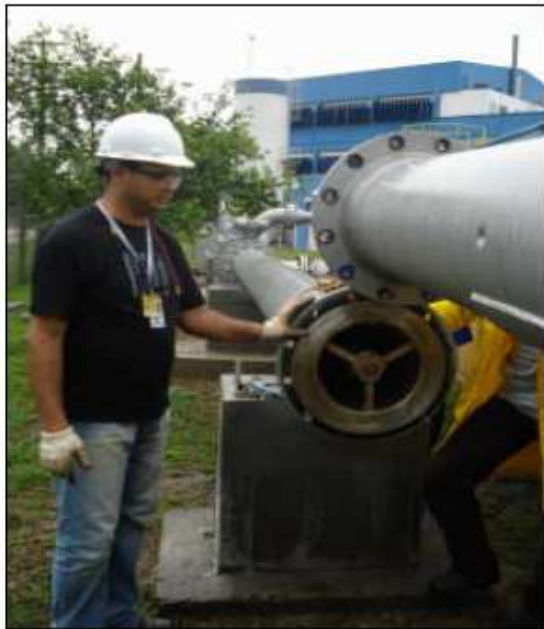
Photo F – Retrieval of Magnetic Filter
(6 Nov 2007)

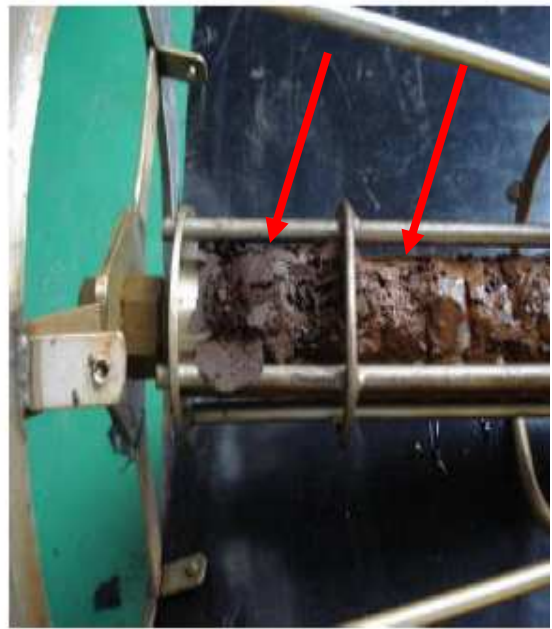
Photo G – Metallic impurities captured
by Magnetic Filter

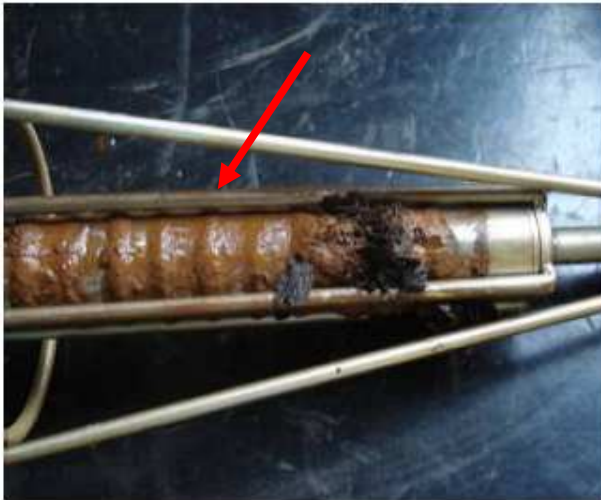
Photo H – Metallic Impurities 6 Nov 2007

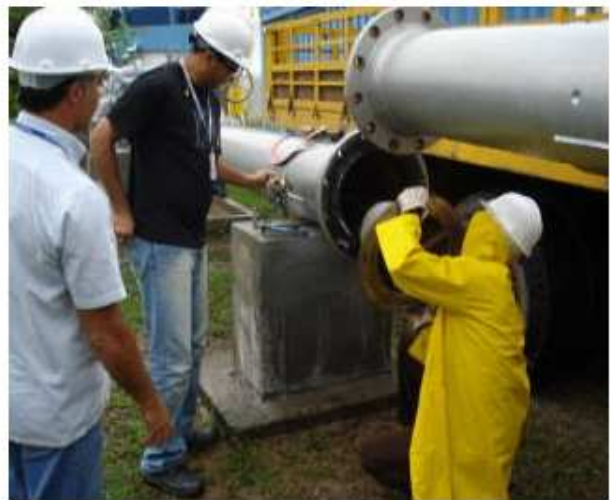
Photo I – Installation of the Magnetic Filter
(6 Nov 2007)

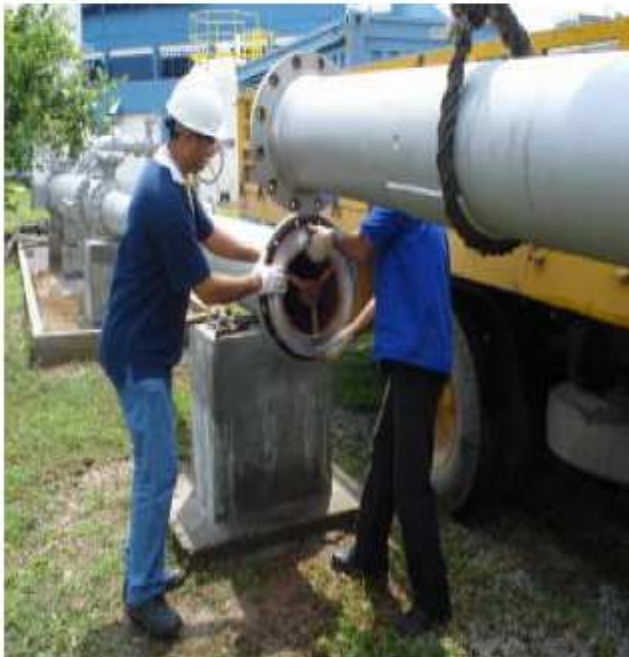
Photo J – Retrieving the Magnetic Filter (8 NOV 2007)

Photo J – Retrieving the filter (8 Nov 2007)

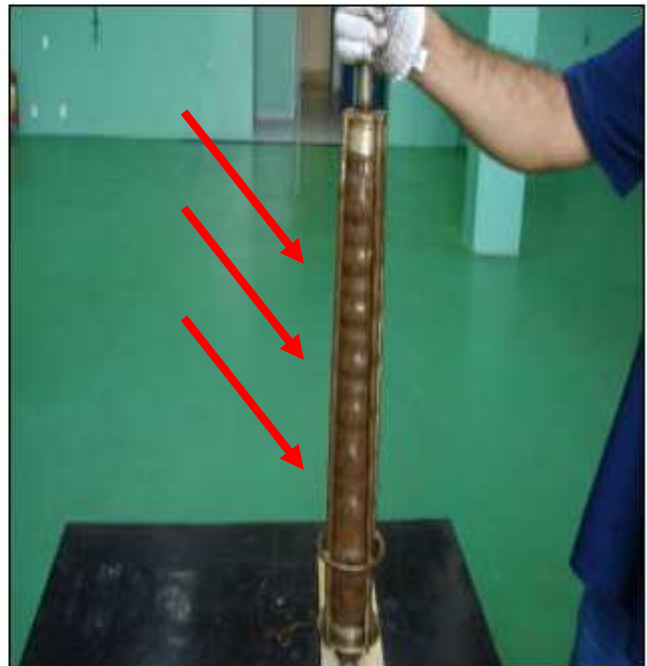
Photo K – Metallic impurities captured by the Magnetic Filter (8 Nov 2007)

Photo K – Metallic impurities (8 Nov 2007)

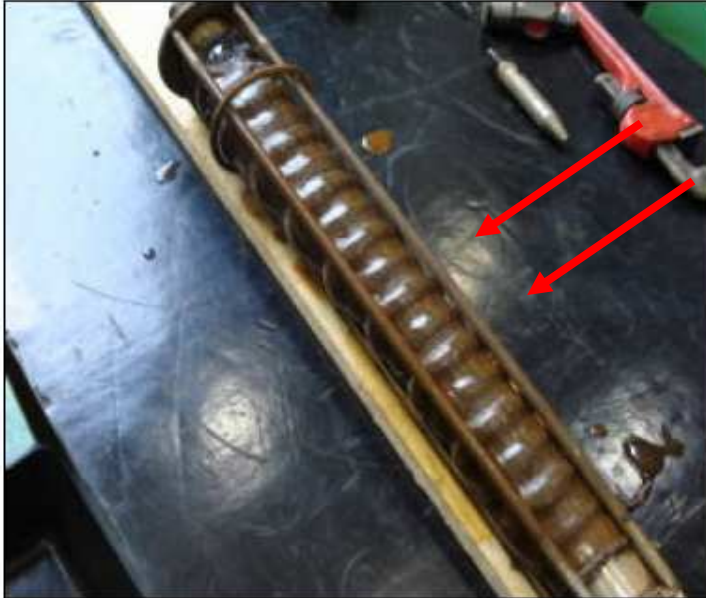
Photo L – Metallic impurities captured by Magnetic Filter

Photo L – Metallic impurities

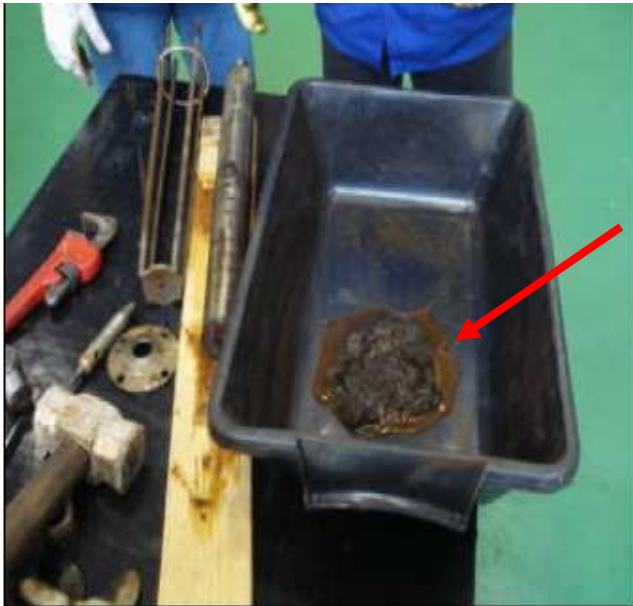
At 11:30 am we evaluated the amount captured on the Magnetic Filter (Photo M)

Photo M – Metallic impurities captured by Magnetic Filter
