## CASE STUDY

**CANYON TECHNICAL**

**QUINTUPLEX PUMP**

**LUBE OIL**

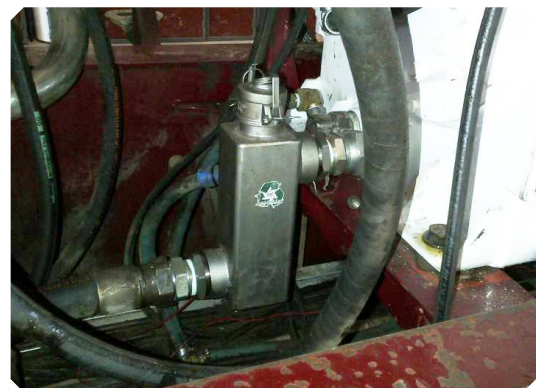
After major failure of several drive ends of the Quintuplex pumps on Canyon Technical's N2 Pumpers, it was determined that metal filings in the lube oil had caused the failures. The lube oil systems were still contaminated from the previous drive end failure, even after the pump was cleaned and re-built.

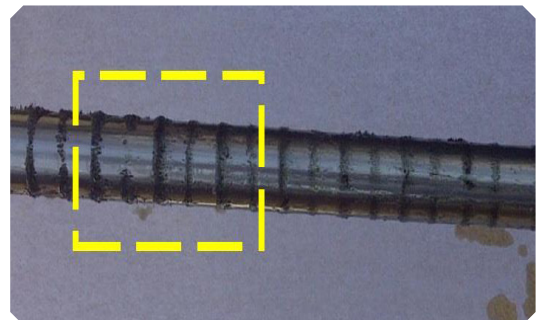
Photos show both the ferrous and non-ferrous contamination captured by the magnetic filter after circulating approximately 200 Litres of Traxon E Synthetic CD 50 oil for just 40 minutes at 120 degrees F. If left in the oil, these metal particles will prematurely wear the pump components and degrade the oil viscosity. This type of proactive maintenance protocol will extend component life and increase uptime.

Install an OEI magnetic filter scrubber prior to the Quintuplex pump on the suction side of the lube oil reservoir to filter out any remaining ferrous contamination in the lube oil filtration system.

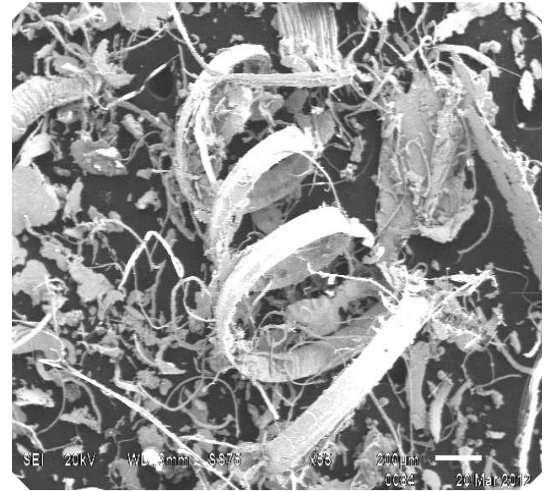
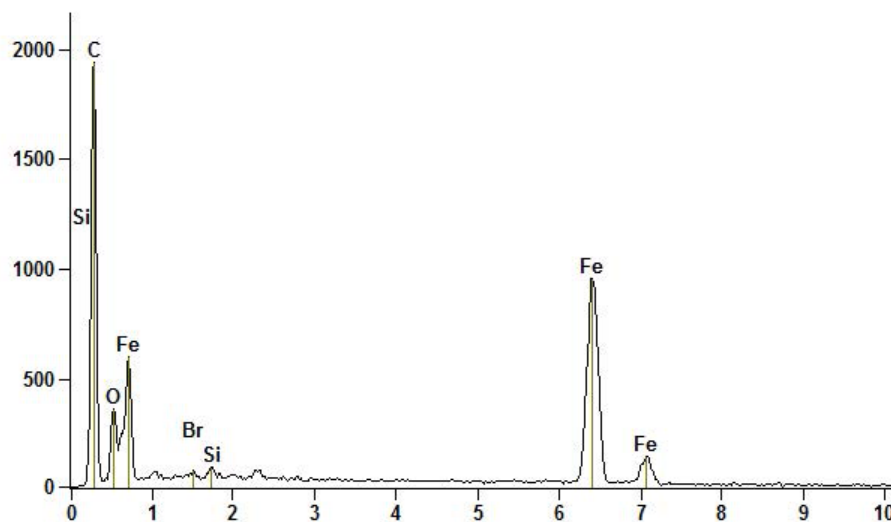
The particles collected by the magnetic filter rod in the form of slivers, flakes and metal cuttings, ranged from 4100 microns to 0.8 microns in size.

The majority of the particles collected are made of Iron (about 97%) as shown on the graph. The photo at the right shows one of the pieces that appears to be the result of shearing off of the shaft. Also trapped on the magnetic filter rod were particles of Silicon, Chromium, Manganese, Molebdenum, Phosphorus, Copper, Aluminum, Zinc and Calcium.
