TESTIMONIALS

DRAGLINES

NO. 2 GEARBOXES

LUBE OIL

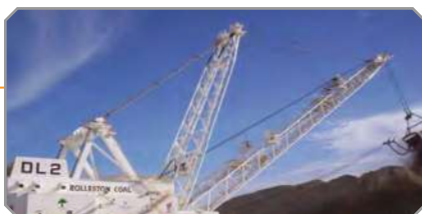
Problem	Maintenance manager was tasked with improving the ISO cleanliness level of all dragline gearboxes operating with 60 gallons of 1000 cst lube oil.
Solution	Install a 12" OEI magnetic filter scrubber (5SC12SCL) on the existing kidney loop system.
Results	Achieved never before realized ISO fluid cleanliness rating of 20-15-12.
