CASE STUDY

MITSUBOSHI BELTING

BOILER

IMPROVED
BOILER
WATER
QUALITY

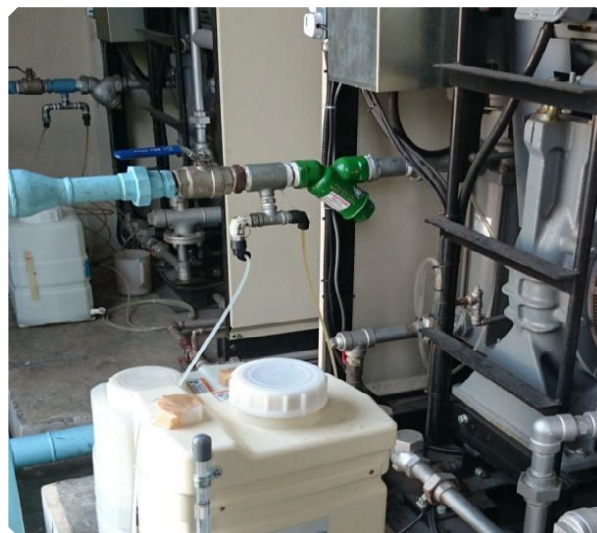
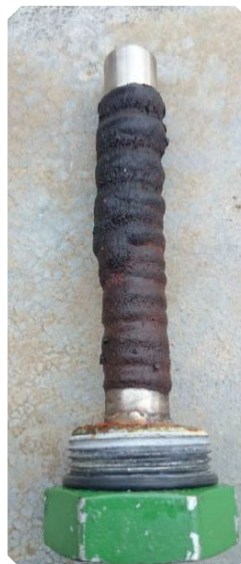
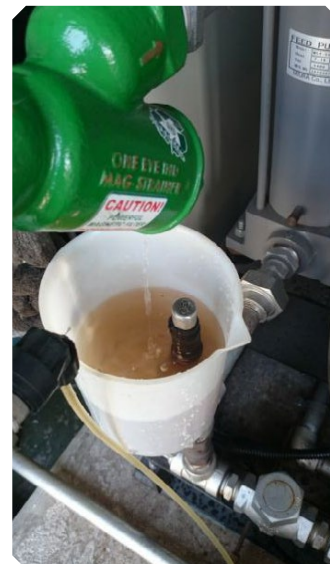
High volumes of iron oxide, resulting from piping corrosion, enter the boiler system and water supply line; the rust contamination continues downstream, degrading process water quality and damaging facility systems.

Photos show the quality of the incoming water as well as the contamination captured after 1 week of operation. The OEI filter has improved the boiler system's reliability and reduced the need for chemical flushing.

Install an OEI magnetic y-strainer suction inside of the water pump on a 2 week trial.
