CASE STUDY

MOMENTIVE PERFORMANCE SRL

CIRCULATION PUMP

TRIMETHOXY(METHYL)SILANE FILTRATION

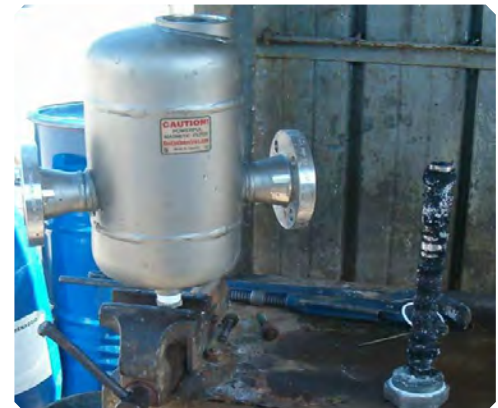
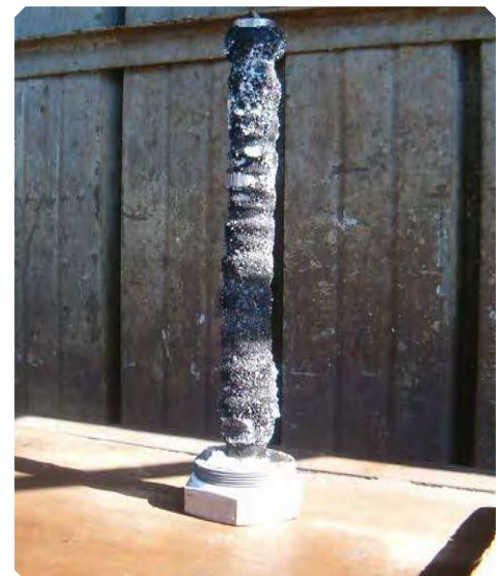
The photos show a substantial amount of contamination collected on the magnetic filter element after 4 months of operation. The first year after installation, there were no pump failures, this resulted in extended maintenance intervals, and reduced operator contact with the Trimethoxy(methyl)silane.

Alex Priori of Renox, the OEI distributor in Italy, suggested the installation of a high-pressure magnetic filter scrubber on the suction side of the circulation pump to filter out the contamination that was causing premature pump and seal failure.
