CASE STUDY

WAJAX INDUSTRIAL SERVICES

NEW TRENCHER HYDRAULIC RESERVOIR

**REDUCED
TIME AND COST
FOR
MANAGING
CONTAMINATION**

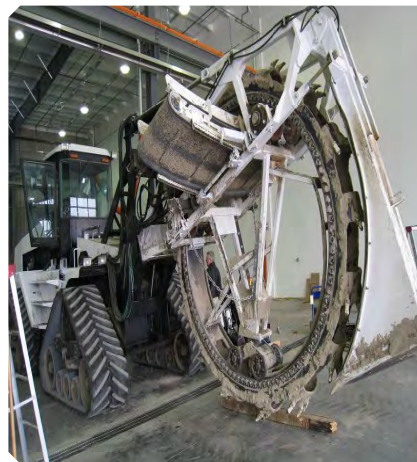
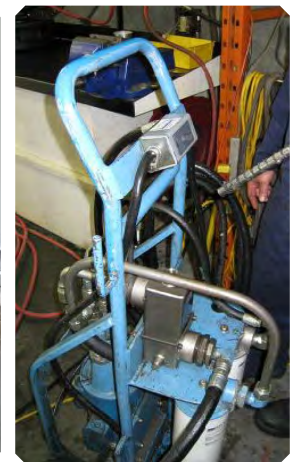
The hydraulics were flushed clean with the kidney loop system, the start up was a success, and the unit was commissioned for operation. The photo shows ferrous wear contamination captured by the magnetic filter element installed in the hydraulic reservoir.

Wajax deployed OEI magnetic filters in the hydraulic reservoir for continuous filtration during operation as well as a portable kidney loop system to circulate and flush the hydraulic fluid before operation.
