## CASE STUDY

ELK, CA USA / JAN 2010

RESIDENTIAL RADIANT-FLOOR HEATING SYSTEM

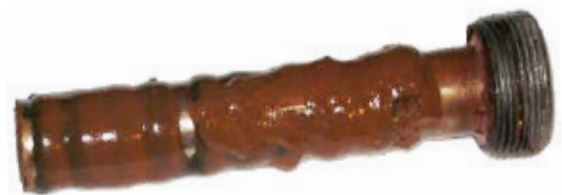
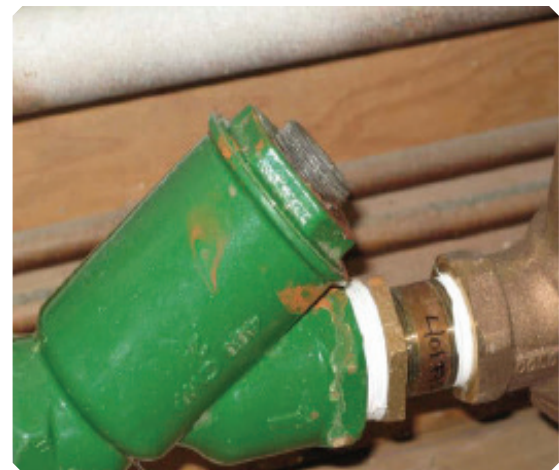
The application of the magnetic filter successfully removed a significant amount of rust contamination from the system. The photo indicates 1 month of contamination collected.

Install an OEI magnetic y-strainer prior to the pump and mixer.
