CASE STUDY

LINEX MANUFACTURING

PARTS WASHER

PRODUCT RECOMMENDATION
MAGNETIC FILTER SCRUBBER

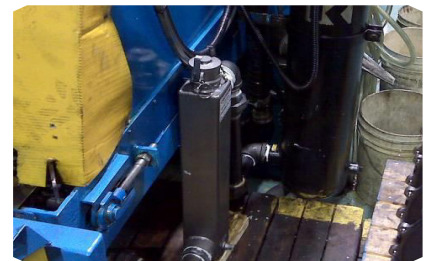
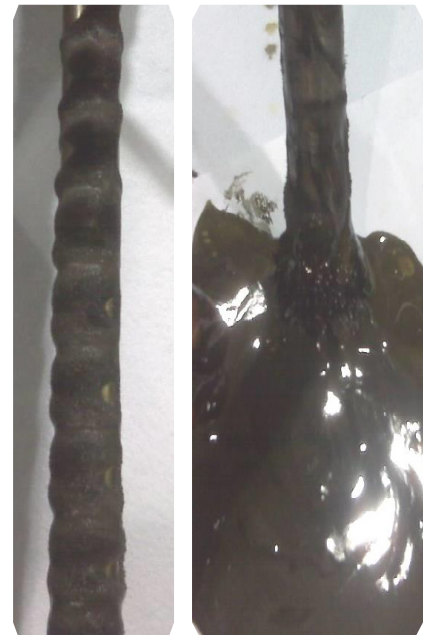
The photos show contamination collected from the washing fluid after 1 week of operation. When the contamination was removed from the magnetic element, it returned to liquid state; this is because so many of the particles collected were below 10 microns in size. Installing the magnetic filter extended traditional filter element life from every 3 weeks, to over 2 months. Product rejection due to cleanliness has been eliminated.
