CASE STUDY

MARION DRAGLINE, BMA OPEN MINE

GEARBOX

SYSTEMS
PROTECTED FROM
WEAR AND QUALITY
OF OIL INCREASED

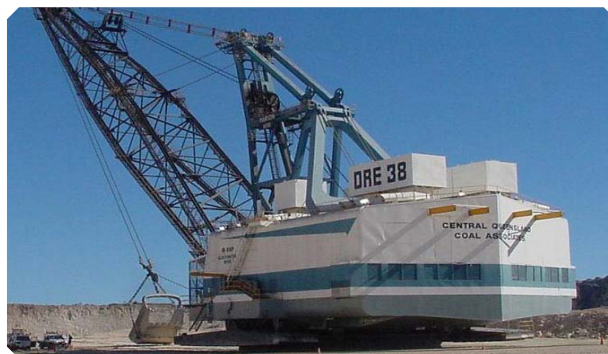
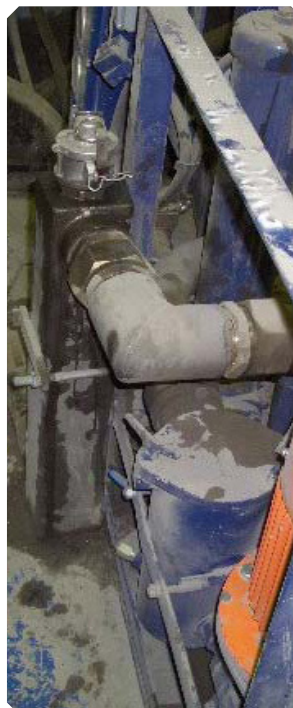
After three days of operation, the OEI magnetic filter was removed revealing a significant amount of ferrous contamination that had been extracted from the gear oil.

Laboratory report showed a sizeable reduction in Particle Quantity count from 3904 to 723. Tim Rantin (Flac Champion) of BMA mines concluded the contaminants removed by the OEI magnetic filter are particles the existing filtration system was unable to capture. These particles will prematurely wear out the gear box components and seals in addition to degrading the fluid.

Install an OEI magnetic filter scrubber to the existing kidney loop filtration system.
