CASE STUDY

SILICON PROCESSING PLANT

MAGNETIC DRIVE PUMP

CARBON STEEL PIPE SYSTEM

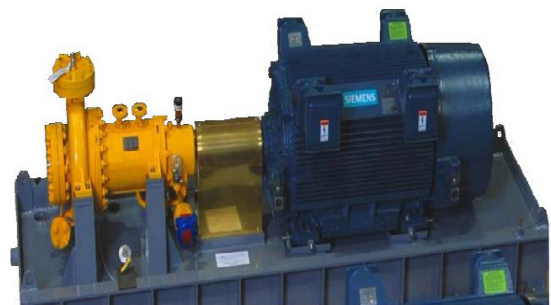
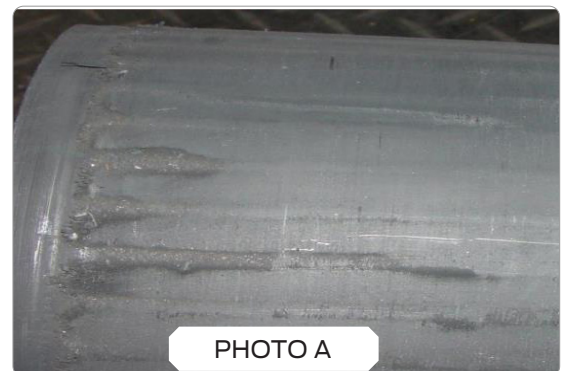
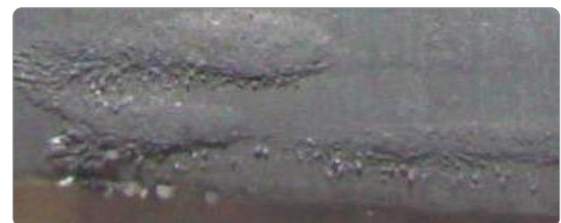
The fine ferrous black powder is magnetically trapped in the impeller drive causing premature wear of the journal bearings, internal shaft, impeller and magnet carrier. (Photo A)

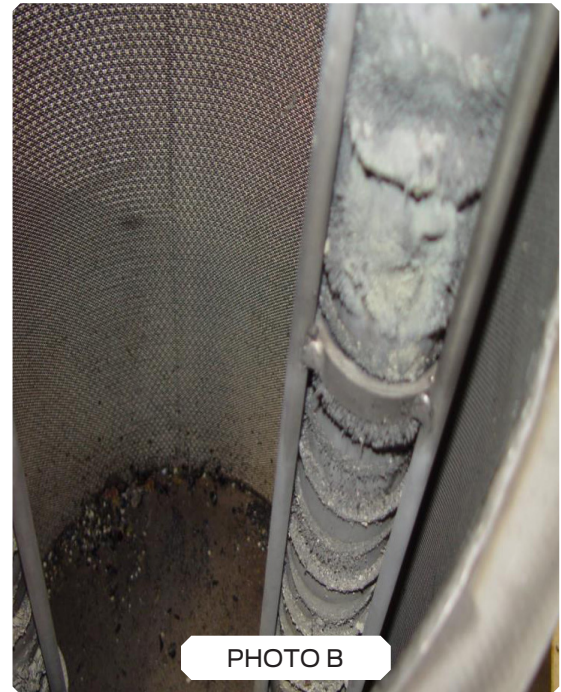
PHOTO B

Photo B – displays a substantial amount of contamination captured by the magnetic separator just 3 days after installation.

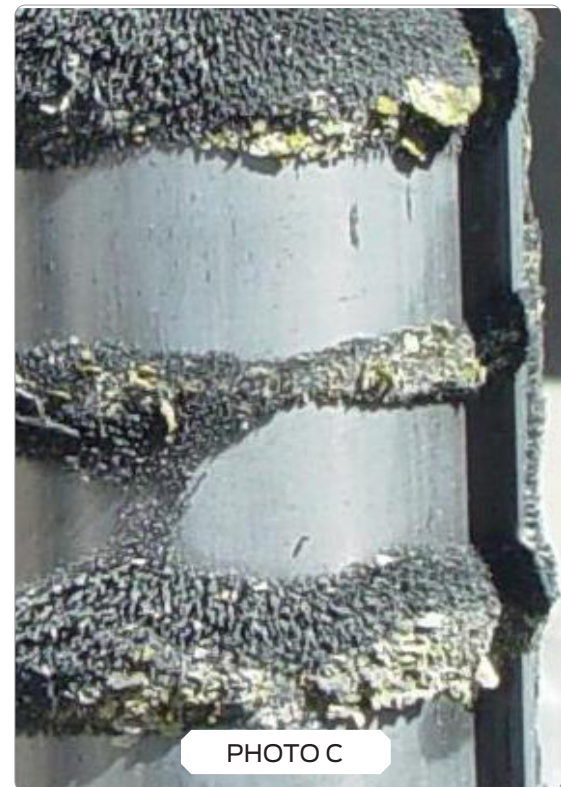
PHOTO C

Photo C: Close up of the magnetic separator, the arrows indicate contamination later identified as non ferrous. The non ferrous contamination is trapped on the magnetic separator by static adhesion. The static charge is created by flow inside the pipe line and attaches to the contamination. When the charged non ferrous contamination is exposed to our powerful magnetic fields they are magnetically extracted from the fluid and trapped on the magnetic separator element.

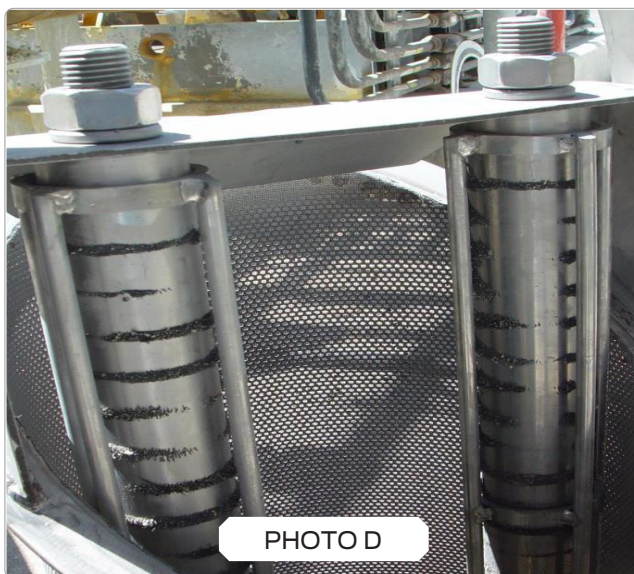
PHOTO D

Photo D: Is the second cleaning of the magnetic separator this shows contamination captured after 3 more days of production.

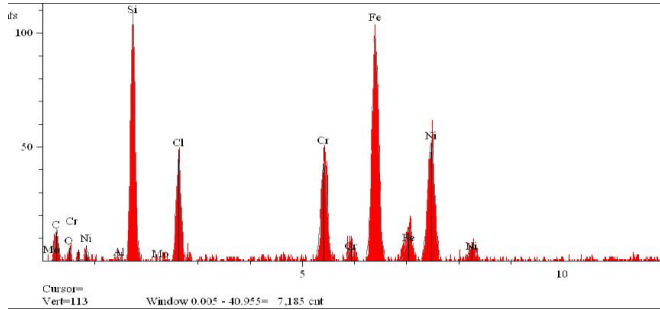
DIAGRAM A

To further test the efficiency of the magnetic separators a fluid analysis was performed extracting a sample prior to the magnetic separator and also after. Diagram A shows the results prior to the magnetic separator and Diagram B are the results after, note the significant reduction in Chromium, Nickel and Iron. These results have influence this client to order additional Magnetic Separators for their new facility and are evaluating additional OEI products to enhance their facility.

Elt.	Line	Intensity (c/s)	Atomic %	Conc	Units
C	Ka	2.18	42.408	16.356	wt.%
O	Ka	0.76	4.020	2.065	wt.%
Al	Ka	0.38	0.322	0.279	wt.%
Si	Ka	19.49	13.398	12.083	wt.%
Cl	Ka	8.77	4.666	5.312	wt.%
Cr	Ka	10.85	5.273	8.804	wt.%
Fe	Ka	25.88	16.552	29.683	wt.%
Ni	Ka	14.72	13.164	24.811	wt.%
Mo	La	0.34	0.197	0.607	wt.%
			100.000	100.000	wt.%

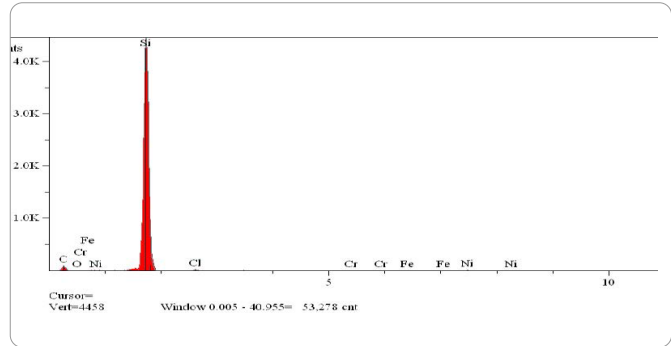
DIAGRAM B

Line	Intensity (c/s)	Atomic %	Conc	Units
C	Ka	15.99	53.237	32.618	wt.%
O	Ka	1.21	0.960	0.783	wt.%
Si	Ka	1,061.78	44.965	64.421	wt.%
Cl	Ka	4.08	0.226	0.408	wt.%
Cr	Ka	2.37	0.132	0.349	wt.%
Fe	Ka	2.11	0.142	0.404	wt.%
Ni	Ka	3.84	0.340	1.017	wt.%
			100.000	100.000	wt.%
