CASE STUDY

BUCKSKIN MINE COMPANY / KIEWIT MINING GROUP

UNIT RIG HAUL TRUCK

STEERING AND HYDRAULIC FLUID

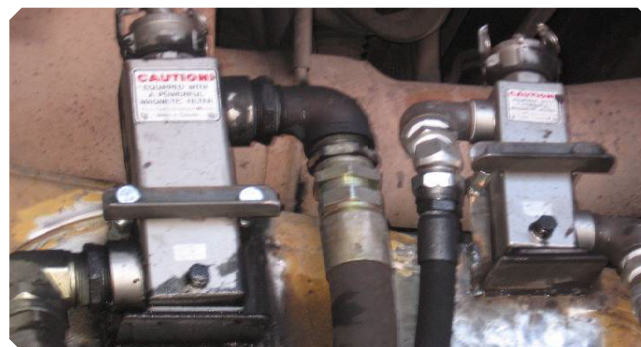
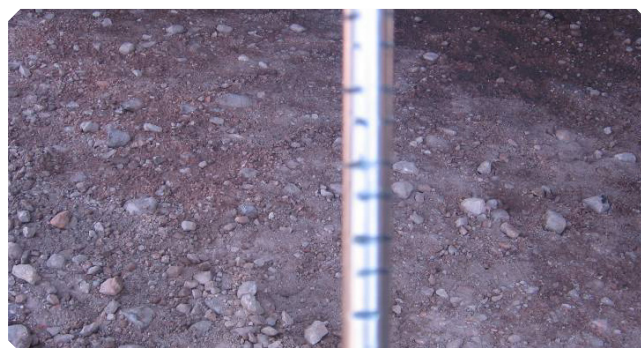
The ferrous contamination trapped on the magnetic rod represents approximately 40 hours of running time. If left in the fluid these metal particles will prematurely wear the components and degrade the fluid viscosity.

Installation of an OEI magnetic filter scrubbers. The steering and hydraulic systems share the reservoir so the scrubbers were installed on the return lines. The power steering pump and fluids were also changed.
