CASE STUDY

KOMATSU 475 DOZER

FINAL DRIVE LUBE OIL

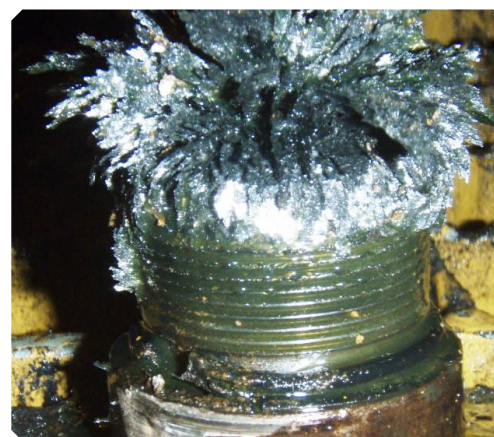
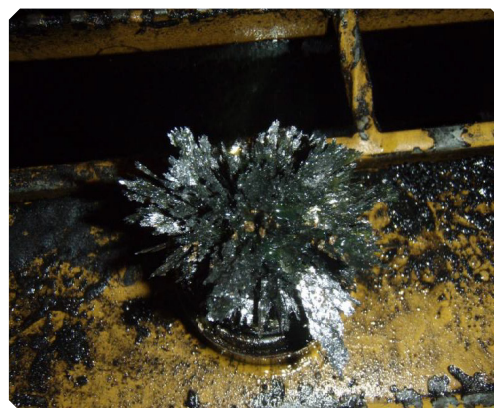
Incompatible lubricant was used on the dozer's final drive resulting in excessive component wear and ferrous contamination build up.

The photos show contamination collected on some of the OEI magnetic filter plugs after 11,420 hours of operation.

Replace OEM magnetic plugs with OEI magnetic filter plugs to capture enough wear contamination that the dozer could remain in operation until new final drives arrived.

The OEI filters successfully kept the dozer in operation until the spare final drives arrived. The mine now employs OEI magnetic filter plugs on all Komatsu and Caterpillar equipment as part of their maintenance and reliability program.
