CASE STUDY

GUN POWDER MANUFACTURER

PROCESS WATER SYSTEM

PROVEN RESULTS

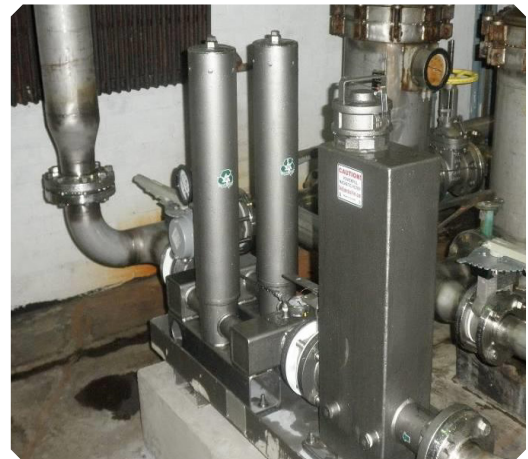
Install an OEI stainless-steel, high flow filtration system combining stainless cloth media filters and OEI patented magnetic filters. This system is capable of handling 450 gpm of water and was installed after the traditional string wound filter system.

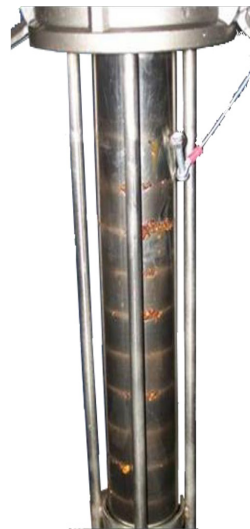
CONTAMINATION CAPTURED BY THE MAGNETIC FILTER ELEMENT

The photos show contamination collected after 2 weeks of operation. The lead Process Chemical Engineer determined the test successful because the facility water now meets municipal water quality standards. The company has since installed multiple OEI filters throughout the facility.

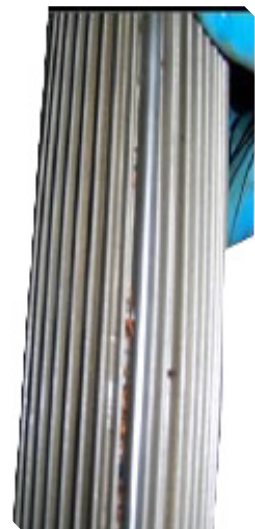
CONTAMINANTS CAPTURED BY THE STAINLESS-STEEL CLOTH ELEMENT
