CASE STUDY

ARCH COAL

P&H 2800 SHOVEL

HOIST CASE OIL

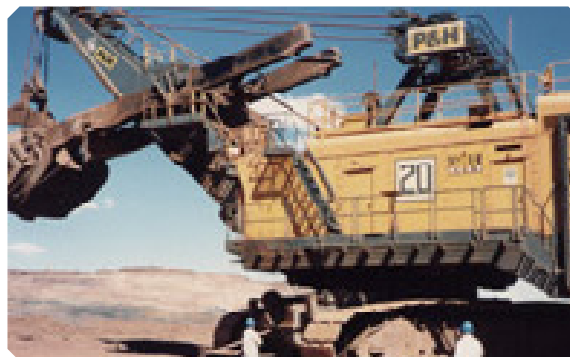
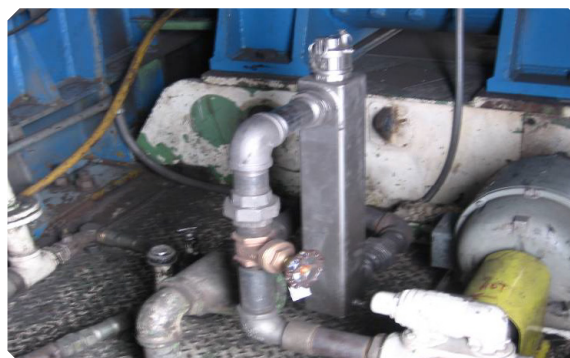
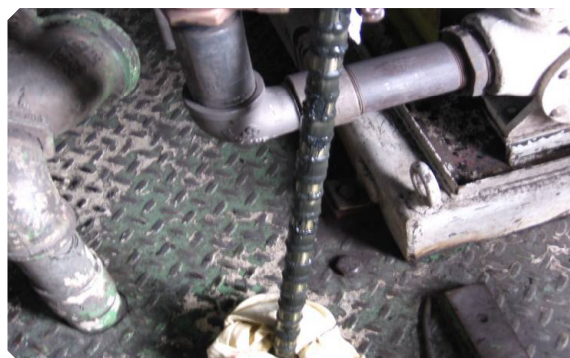
A customer was experiencing an excessive amount of ferrous contamination in the P&H 2800 Shovel.

After only 30 minutes, a substantial amount of ferrous contamination was extracted and trapped on the OEI magnetic filter. If left in the fluid these metal particles will prematurely wear the gearbox components and degrade the fluid viscosity.

Install an OEI magnetic filter scrubber, in line with a circulation pump.
