CASE STUDY

NORTH AMERICAN CONSTRUCTION GROUP

WATSON FOUNDATION DRILL 3100

HYDRAULIC FILTRATION

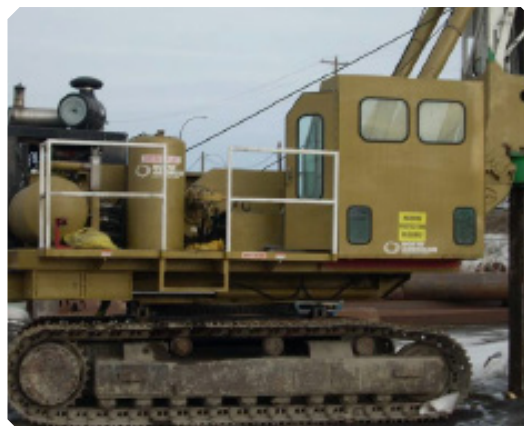
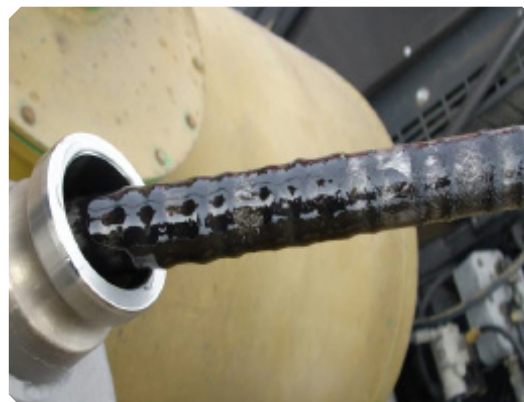
Premature wear of hydraulic system components as a result of ferrous contamination resulting in down time for repairs.

A photo shows the results of the magnetic filter, the captured contamination is ferrous metal down to submicron levels. This contamination was flowing through the traditional filters and causing premature wear resulting in equipment failure. This metal also cuts holes in the traditional filtration media (worm holing).

Permanent installation of a modifying a 5000 series magnetic filtration scrubber onto the existing return manifold.
