CASE STUDY

PT. ECCO TANNERY

HYDRAULIC PRESS

PRODUCT
RECOMMENDATION
**MAGNETIC FILTER
ELEMENT**

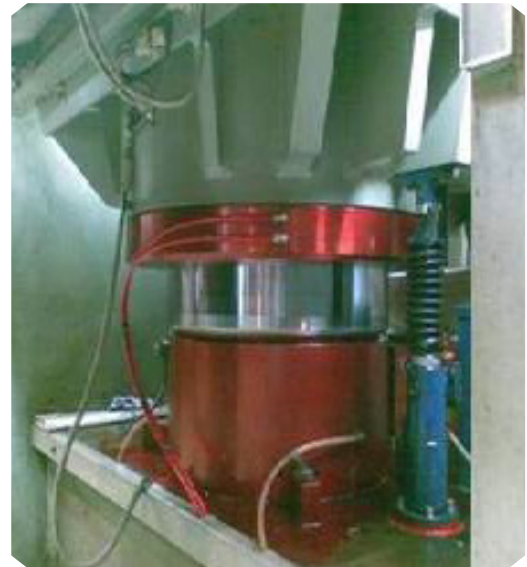
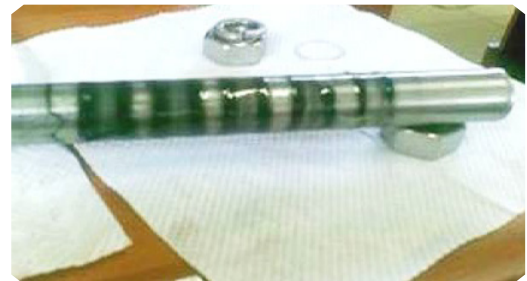
After only 5 days of operation the magnetic filter rod was removed for inspection, when analyzed the particle size is down to submicron and is mainly ferrous metal with small quantities of and silica dust. This size of contamination flows through traditional filtration systems. Installation of the magnetic filter prior to the high pressure pump will also extend the life of the pump and other components in the system.

PT. Sinarmentari Indoprima our Indonesian distributor for OEI recommended installing an OEI magnetic filter rod prior to the hydraulic pump to filter out the submicron ferrous and non ferrous contamination.
