Black Powder / Buffer Gas

Magnetic Separator – 5YS1F6A

Poor Buffer Gas Fluid Main Cause of Gas Compressor Seal Failure

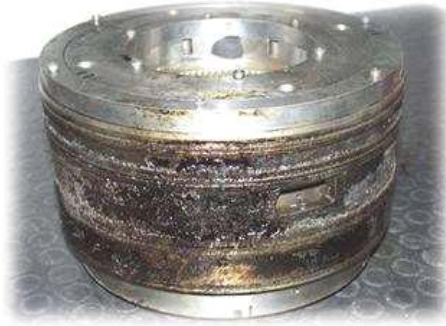
Shown is a seal that failed due to lack of continuous clean, dry buffer gas. John Crane reports that such a deficiency causes a majority of the seal failures the company sees during compressor refurbishments. Photo courtesy of John Crane Inc.

Delrahim says that getting to the root of the problem begins with the proper analysis of mechanical failure. This involves a review of gas composition, commissioning procedures and control system design, along with the interface between the seal, compressor and the control system. Further, it is essential to gain an understanding of the control system piping/instruments diagram and its related pre-established software that allows logic input for safe unit operation.
