CASE STUDY

KINNECOTT ENERGY, RIO TINTO MINING CORP

HAUL TRUCK

CHAIN CASE OIL

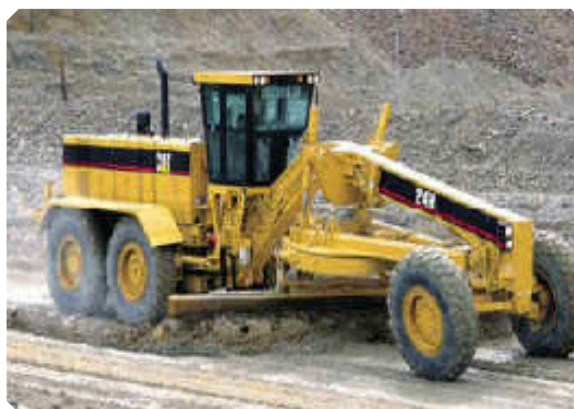
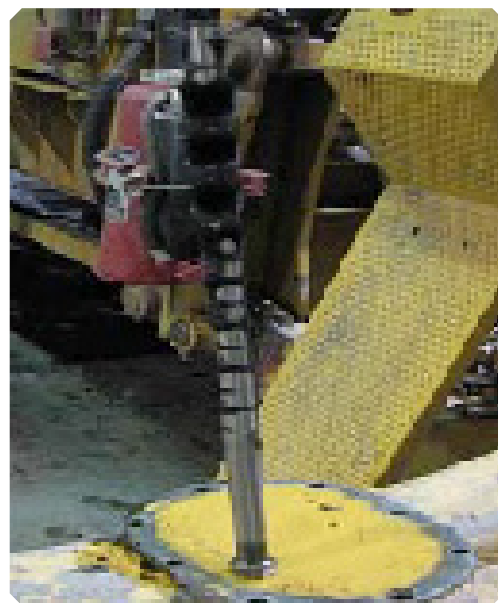
Install an OEI magnetic filter element in the chain case inspection plate. The magnetic filter is located in the central splash area for maximum filtration and does not interfere with the operation.

After 250 hours of operating time a substantial amount of ferrous contamination was extracted from the chain case oil where there is no filtration thereby reducing wear and extending component and lube oil life.
