CASE STUDY

SURFACE LIGNITE MINE

BULK DIESEL TANK

DIESEL TANK FLUSHING

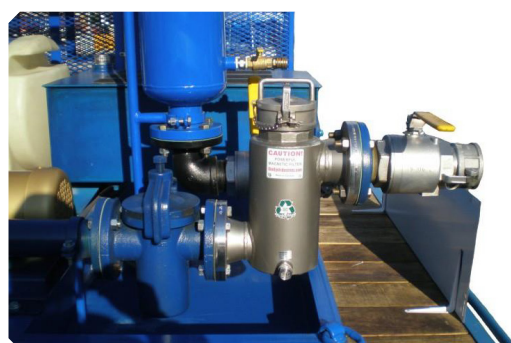
The presence of contamination in the diesel fuel tank causes damage to fuel system components including the circulation pump. Traditional filtration is unable to remove the most damaging contamination (below 10 microns) effectively causing premature wear of the injectors, actuators, and camshaft.

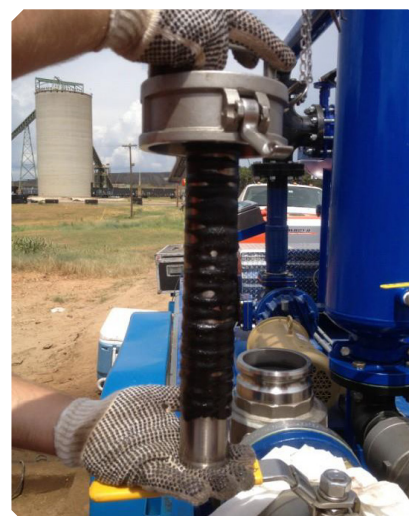
The photo demonstrates the tremendous amount of contamination removed by the magnetic filter that traditional filtration would have missed. By removing the ferrous contamination to submicron levels the diesel fuel is cleaned to a much lower ISO level than the standard (18/16/13) and the life of the pump and the fuel system components are increased. The life of the traditional filter is also extended. The higher level of cleanliness of the fuel results in a more efficient burn and reduced emissions.

Mark Scott a Mining Specialist for Applied Energy suggested the installation of an OEI magnetic filter scrubber as a pre-filter on the suction side of the circulation pump in order to protect it from premature wear and improve the fuel quality.
