## CASE STUDY

TARGA RESOURCES

RECLAIMED OIL TANK

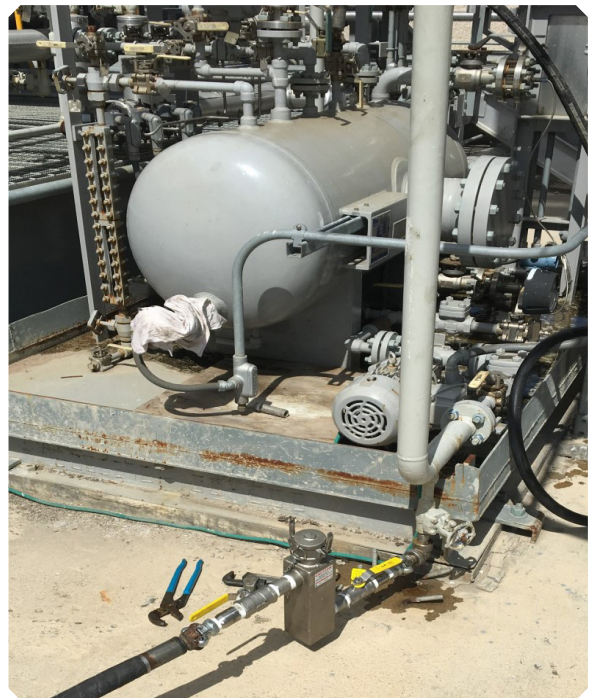
1. Install the OEI Magnetic Filter in a drain line in the discharge.
2. Route the hose to a vent in the destination tank.
3. Record results after 3 minutes, 10 minutes and 1 hour.

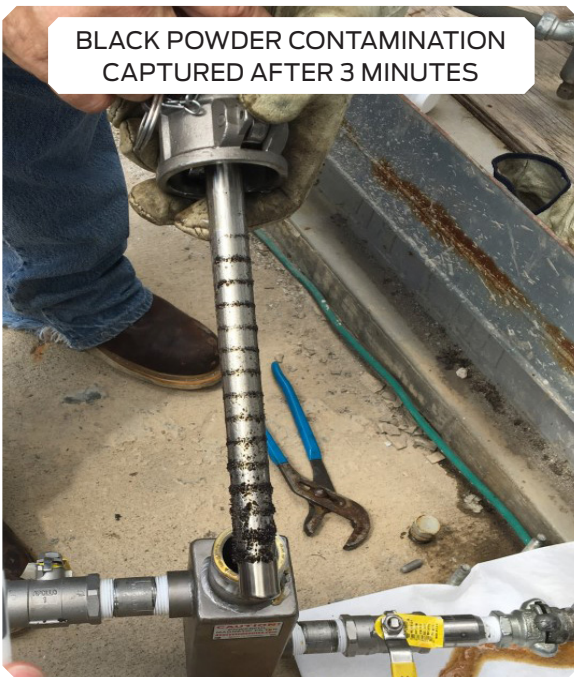
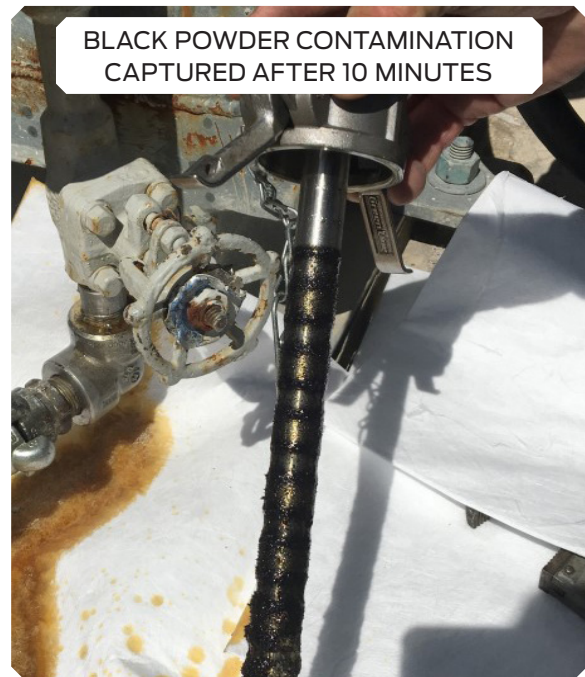
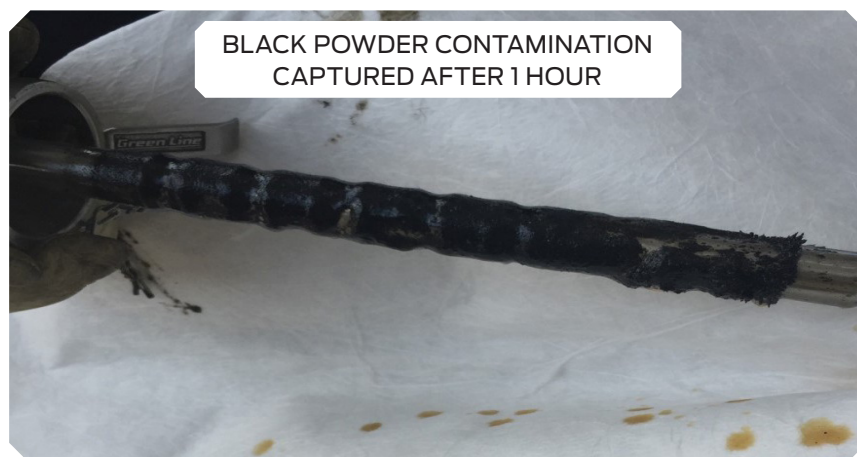
Install an OEI Magnetic Filter on this system to clean the reclaimed oil before it returns to the compressor.
