## CASE STUDY

NORTH PARKES RIO

TINTO COPPER MINE, AUSTRALIA / JUN 2009

CONVEYOR DRIVE GEARBOX FLENDER

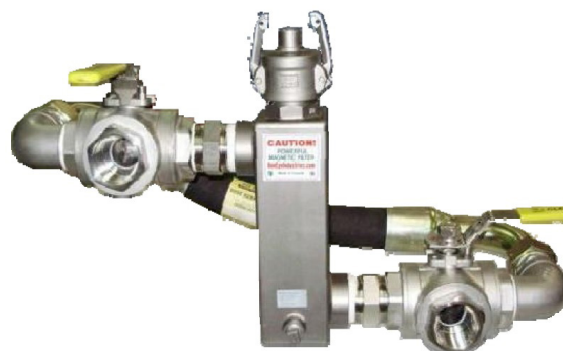
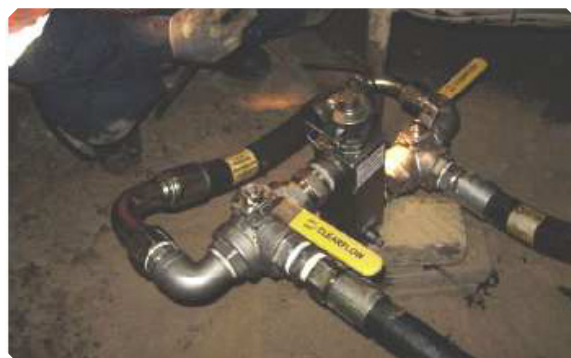
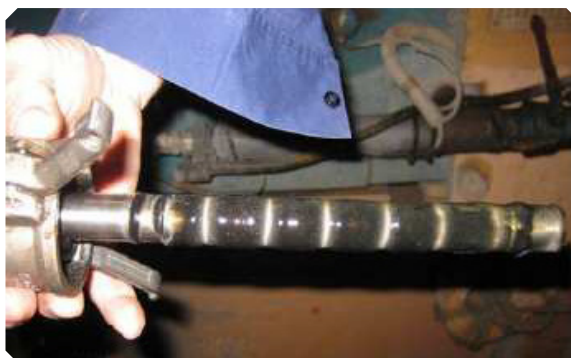
After one week in service the magnetic filter was removed from the scrubber housing and a substantial amount of ferrous contamination was trapped on the magnetic filter and the oil was visually cleaner.

Install an OEI magnetic filter scrubber on the coolant circulation loop with a flow rate of 5 L/min. with a bypass for servicing during operation.
